Robson Lapina

Forensic Engineers, Architects, Scientists & Fire Investigators

GABRIEL G. ALEXANDER, P.E.
Mechanical Engineer

Post incident inspection of the vehicle revealed that the lower safety cable above the cab on the driver's side had failed.

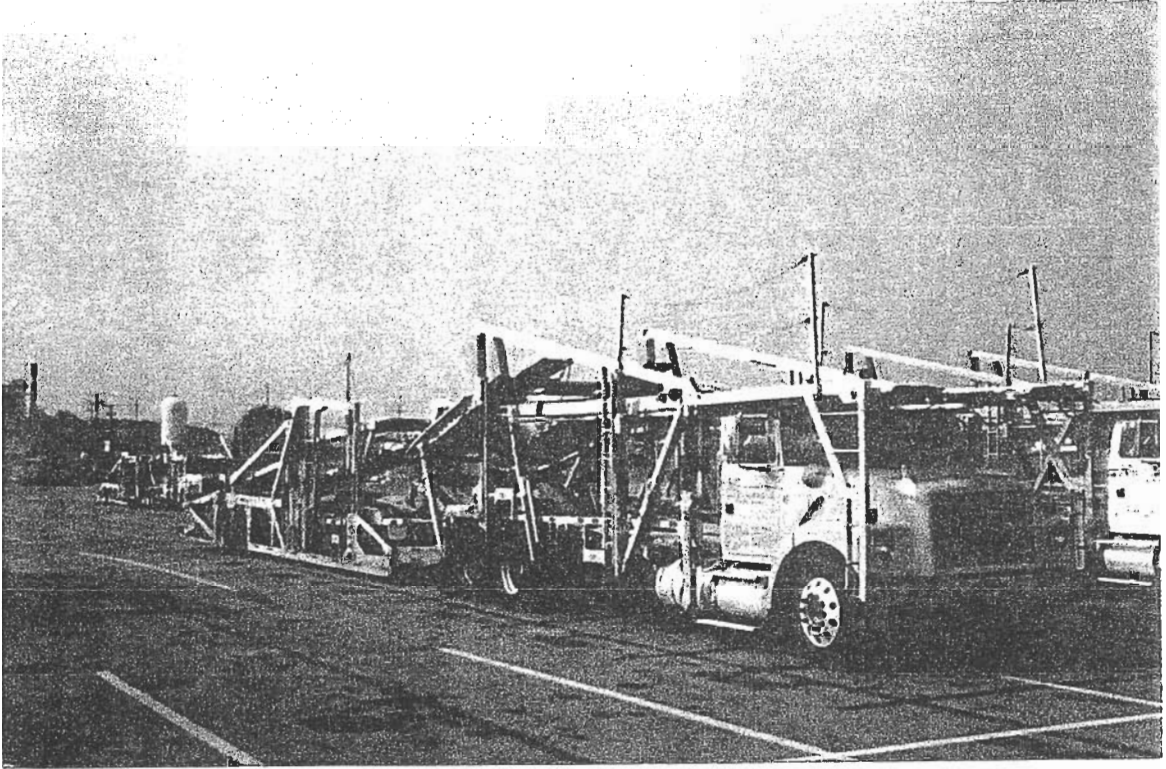
PHOTOGRAPH 6

Photograph 6 through 15 are various views of the incident unit taken about 9/19/2002. Photograph 6 is an overall view of the incident vehicle as viewed from the front right. Photograph 7 is a close-up of the incident cab as viewed from the front left and reveals the incident top deck head ramp.

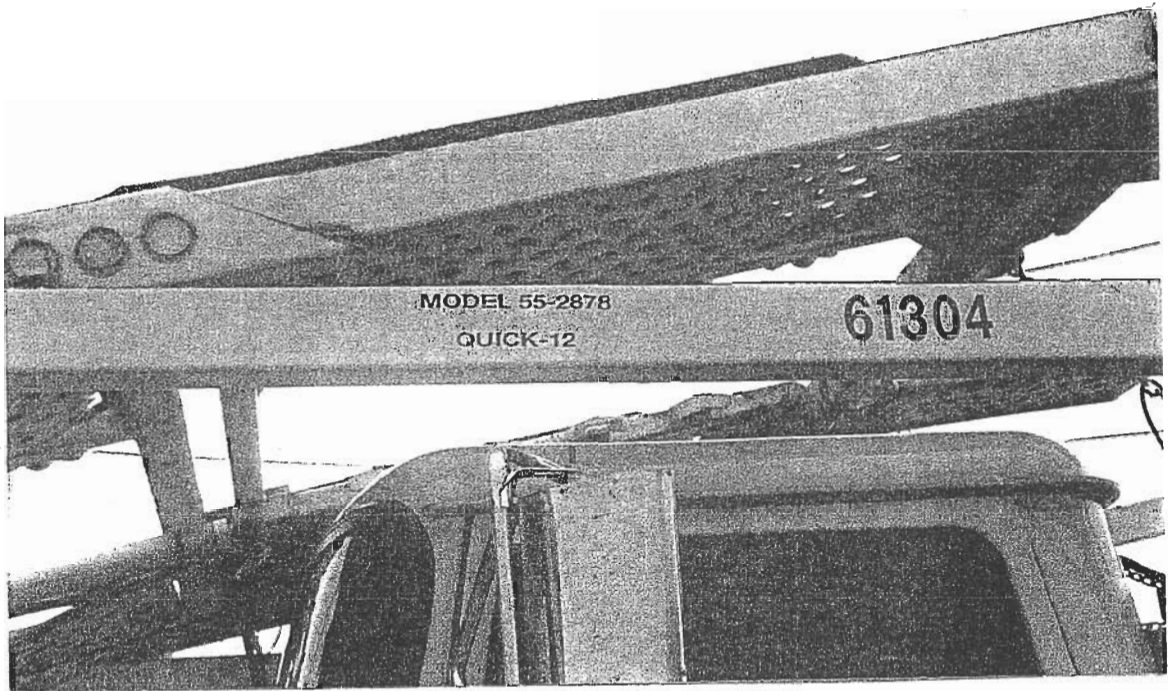
PHOTOGRAPH 10

Photograph 9 is a view of the vehicles VIN data plate. Photograph 10 is a close-up view of the unit just above the cab on the driver's side and reveals the unit number and CCI model number.

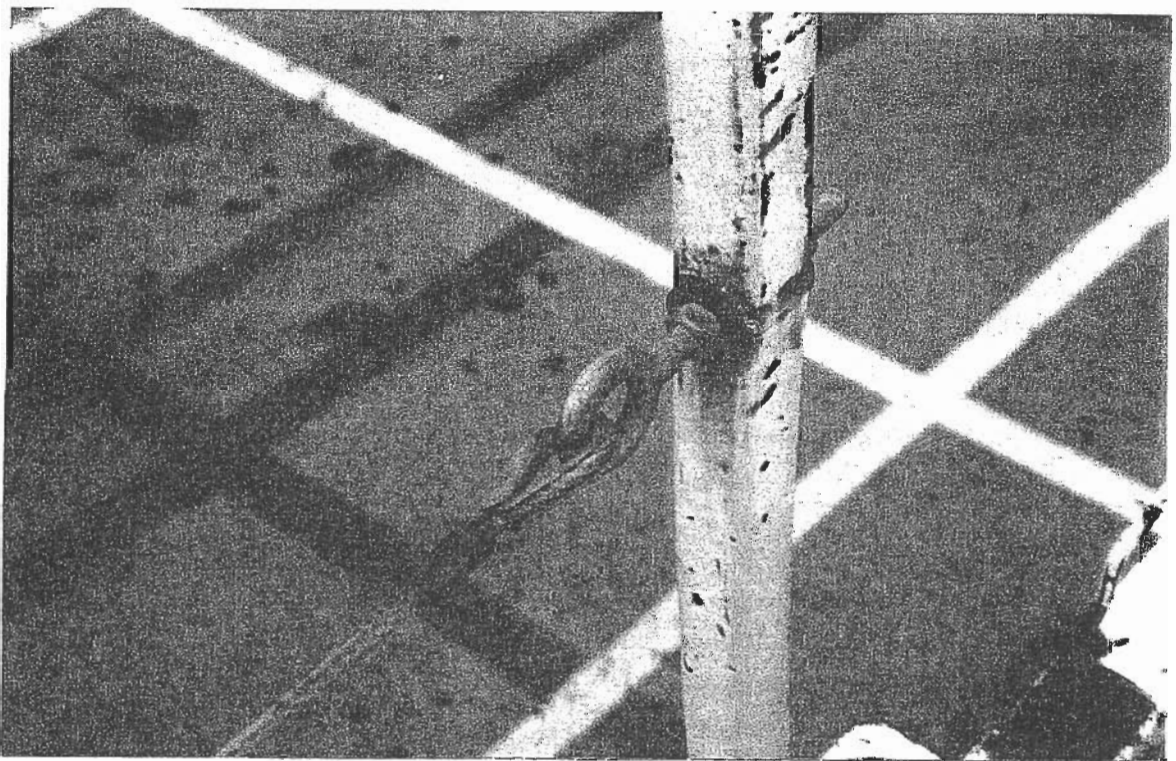
PHOTOGRAPH 11

Photograph 11 is a close-up view of a typical safety cable attachment. At the time of this inspection all four safety cables were of the thimble and eyebolt cable connection design.

Photographs 12 and 13 are close-up views of the safety cables and reveal the height of the cables from the top deck head ramp. Further, as can be seen from Photographs 11 through 13 the cables are coated with a clear material and that the cables are not rusty.

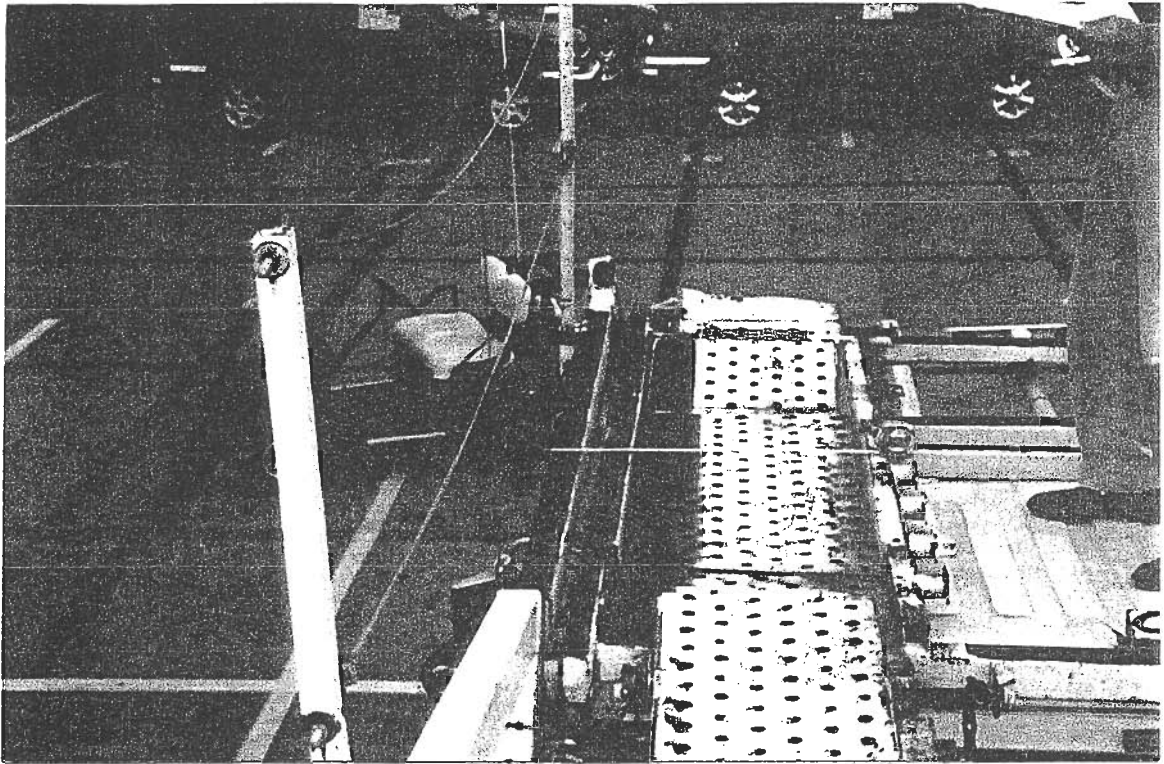
PHOTOGRAPH 14

Photographs 14 and 15 are close up views of the top deck head ramp's walking surface and reveals the presence of black slip resistant paint.

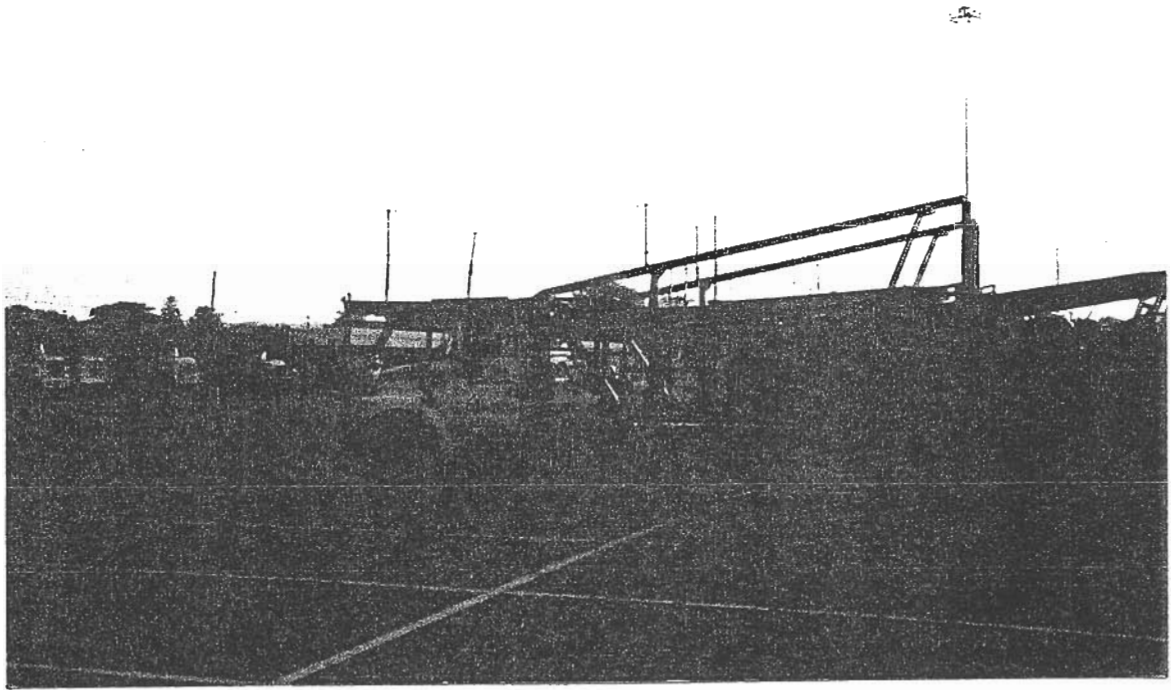
PHOTOGRAPH 16

Photographs 16 through 21 are various views of an exemplar auto transporter. Photographs 17 through 21 reveal that there were three safety cables that utilized thimble and eye bolt connections at the ends of the cable. Further, there was one safety cable that utilized stud threaded aircraft fittings that were swaged to the cable. As can

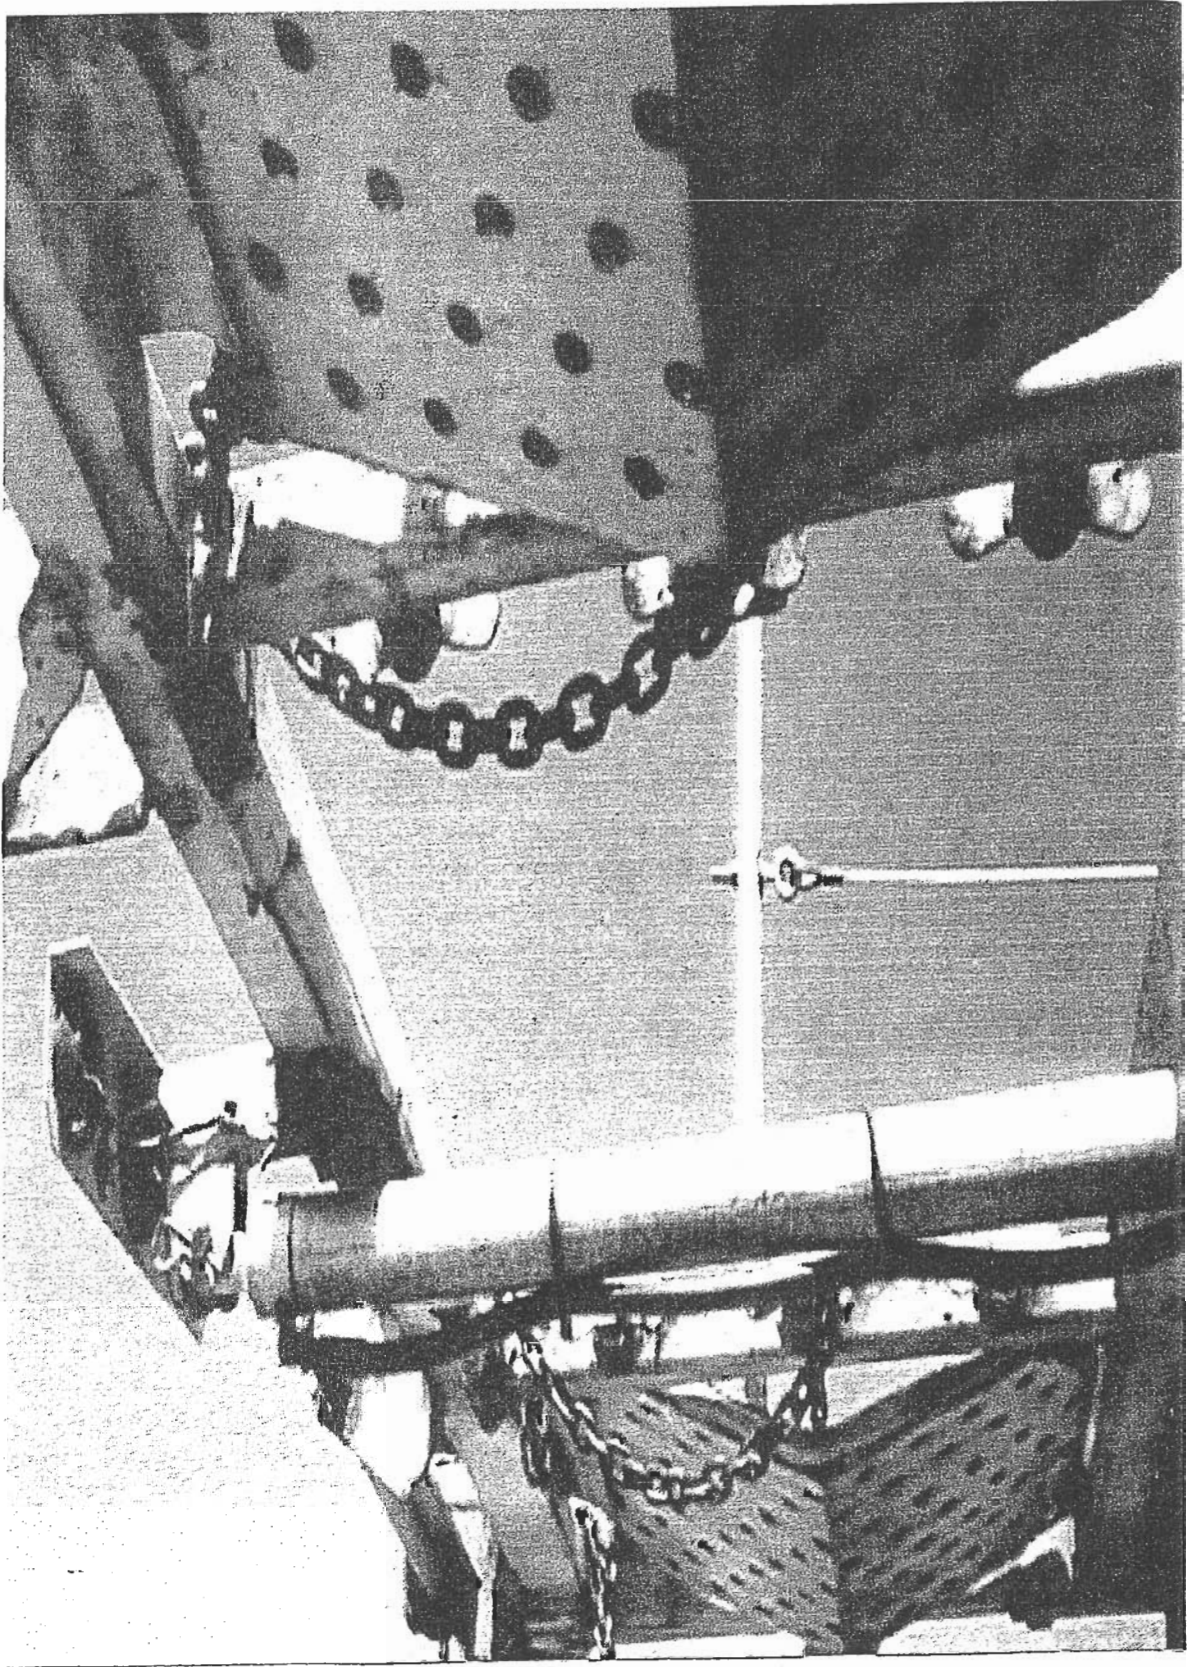
PHOTOGRAPH 45

As can be seen from Photographs 1 through 5, 45 and 46 at the time of the incident there were three safety cables that utilized thimble and eyebolt connections at the ends of the cable. Further, there was one safety cable that utilized stud threaded aircraft fittings that were swaged to the cable.
